## CUSTOMER SUCCESS STORY

# DELIVERING VALUE WITH SEMI-CONTINUOUS DATA COLLECTION

INDUSTRY | Plastic Fabrication

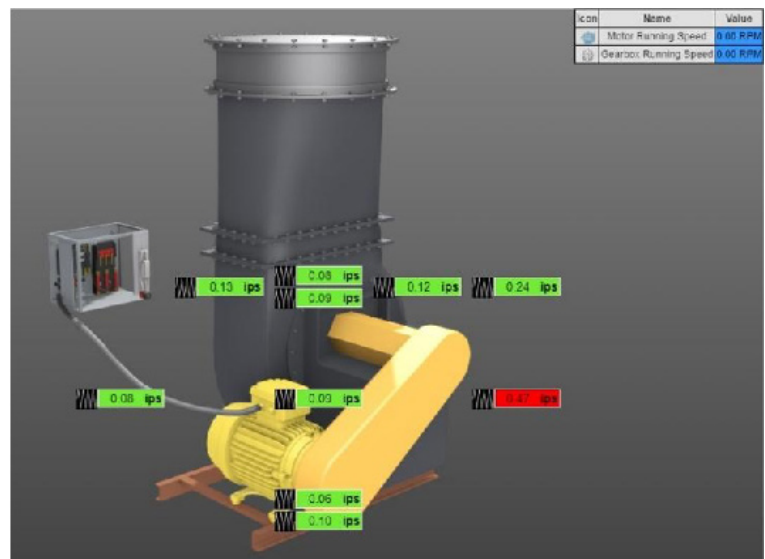
Our wireless system detected a 3xRPM and overall data peak that exceeded the alarm threshold thus sending an alarm to the Allied Analyst. The anomaly was immediately identifiable from Allied’s SmartCBM™ application.

A full review of the data indicated that aerodynamic forces were in play. Specifically, the output of the fan had a severe blockage. The analyst created a fault entry report for the customer and communicated to everyone who was impacted. The report clearly outlined the assessment and the repair recommendation.

Further inspection revealed that product had clogged the entire baghouse and ‘bridged’ over 50% of the ‘dumps’, causing a turbulent flow issue. The facility was shut down to complete the repair, which took less than 15 minutes.

SmartCBM visual showing inboard bearing in alarm

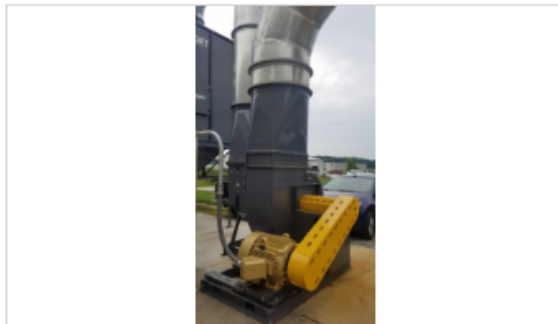
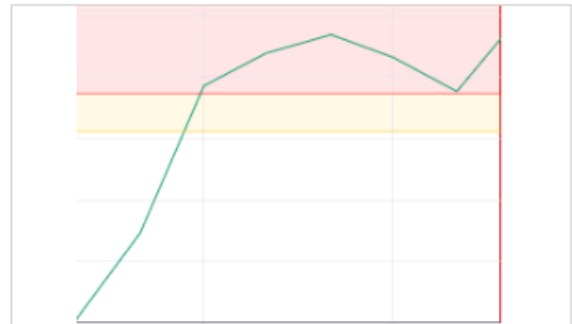
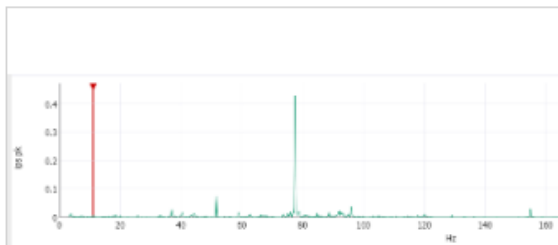
**Analysis Comment:** A 3XRPM peak is present and extremely high. Overall trend values have increase substantially and broke alarm levels.

**Failure Mode:** Restricted

**Part Name:** Impeller Blades

**Reason:** Blockage

*Fault entry report capturing analysis and repair recommendation for client*

**Repair Recommendation:** Check for blockage or restrictions on the discharge side of the blower.
